REPORT NO. UMTA-MA-0099-81-2

VIBRATION LEVEL DATA
BRIGHTON-NEW YORK CITY TRANSIT AUTHORITY

FEBRUARY 1981
FINAL REPORT

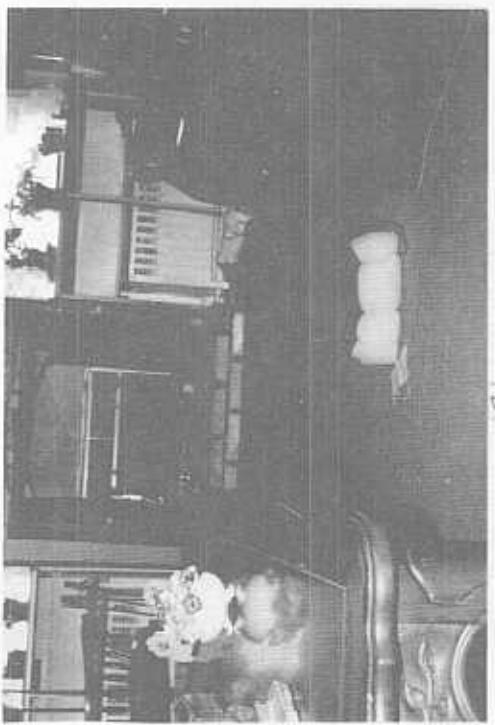
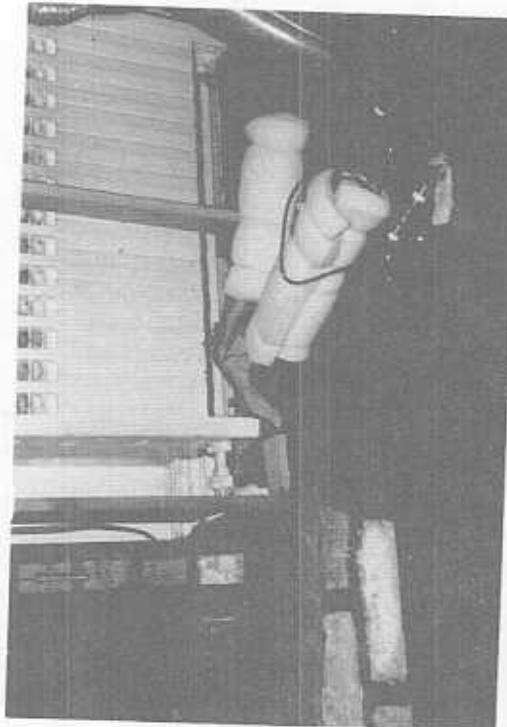
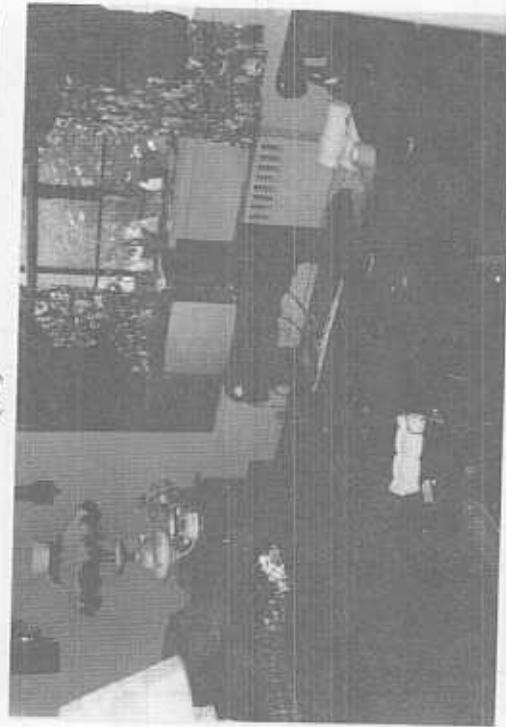
FIGURE 4. PHOTOGRAPHS - PRIVATE RESIDENCE, BROOKLYN NY, NYCTA BRIGHTON LINE
 A - LIVING ROOM B - LIVING ROOM, ACCELEROMETER AT LOAD-BEARING WALL
 C - DINING ROOM D - DEN

In each of the three rooms, vibration transducers, mounted on the floor in the center of the room, monitored vibration levels in the vertical axis. In addition, two vibration transducers, mounted on the floor within six inches of a load-bearing wall, monitored vibration levels in the vertical and transverse (perpendicular to the track) axes (see photograph Figure 4).

In all three rooms, at the load-bearing wall locations, two accelerometers were mounted on the vertical and transverse faces of one-inch brass cubes. Each cube was attached to the flooring with beeswax (In the dining room, it was attached directly to the asphalt tile; in the living room and den, the rug was peeled back

from the wall and the cube was attached to the hardwood flooring) (see photograph Figure 4).
